Client: Queensland Transport

Location: South East Busway, Mt Gravatt (Brisbane, Qld)

CASE STUDY No 4: SUPPORT FOR FAILED RETAINING WALL

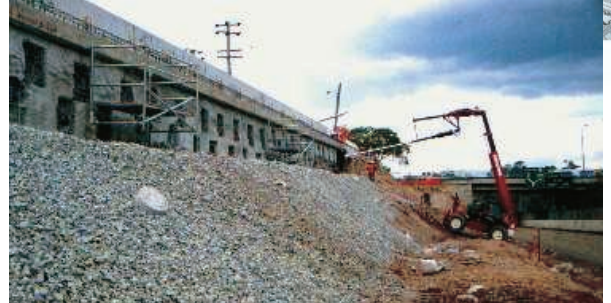
(Above) Screw pile being installed through penetrations cut in the shotcrete wall

Instant Screw Piling devised a procedure for cutting holes in the existing shotcrete wall, installing screw piles, tensioning them, and tying them in to the (repaired) shotcrete wall.

Sections were cut out of the shotcrete wall to allow the screw sections to be driven in. A telescopic handler with a planetary drive head was selected for this job, as it could stand at the base of the wall, pick the screw pile sections from the road above, and install the screw piles. For longer screw piles, shorter sections were butt-welded together. A rock bit was welded to the screw pile to allow it to anchor in rock.

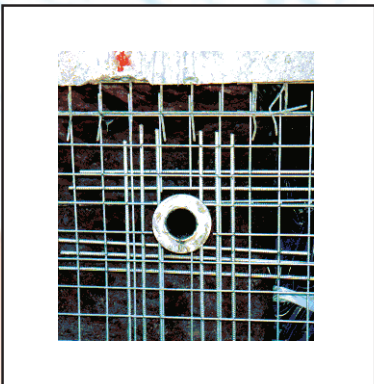
(left) Flange welded to the pile cap to allow tensioning

A flange with a protruding M20 rod was welded to the top of the piles. The shotcrete was reinstated, and then the pile was tensioned to 10 tonnes with a torque wrench, using bracing across the solid (uncut) sections of the wall, effectively transferring tension into the shotcrete wall.
